Manhole Inspection Summary

Manhole # S29AA_010MH

Insp Date: **11/26/07 3:00 PM**

Location Address: **500 PRESTON ST**

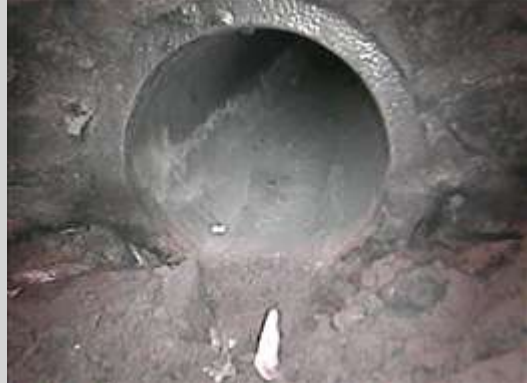
12 O'Clock Outflow

8 in. Circular Gravity Sewer
Pipe Out @ 12 O'Clock

Silt Depth: **3** (in.) Deposits Extent: **Medium**

Infiltration: **None** Pipe Seal Cond: **Sound**
